Surface & Coatings Technology

Study of the electrical properties of ion irradiated polymer materials

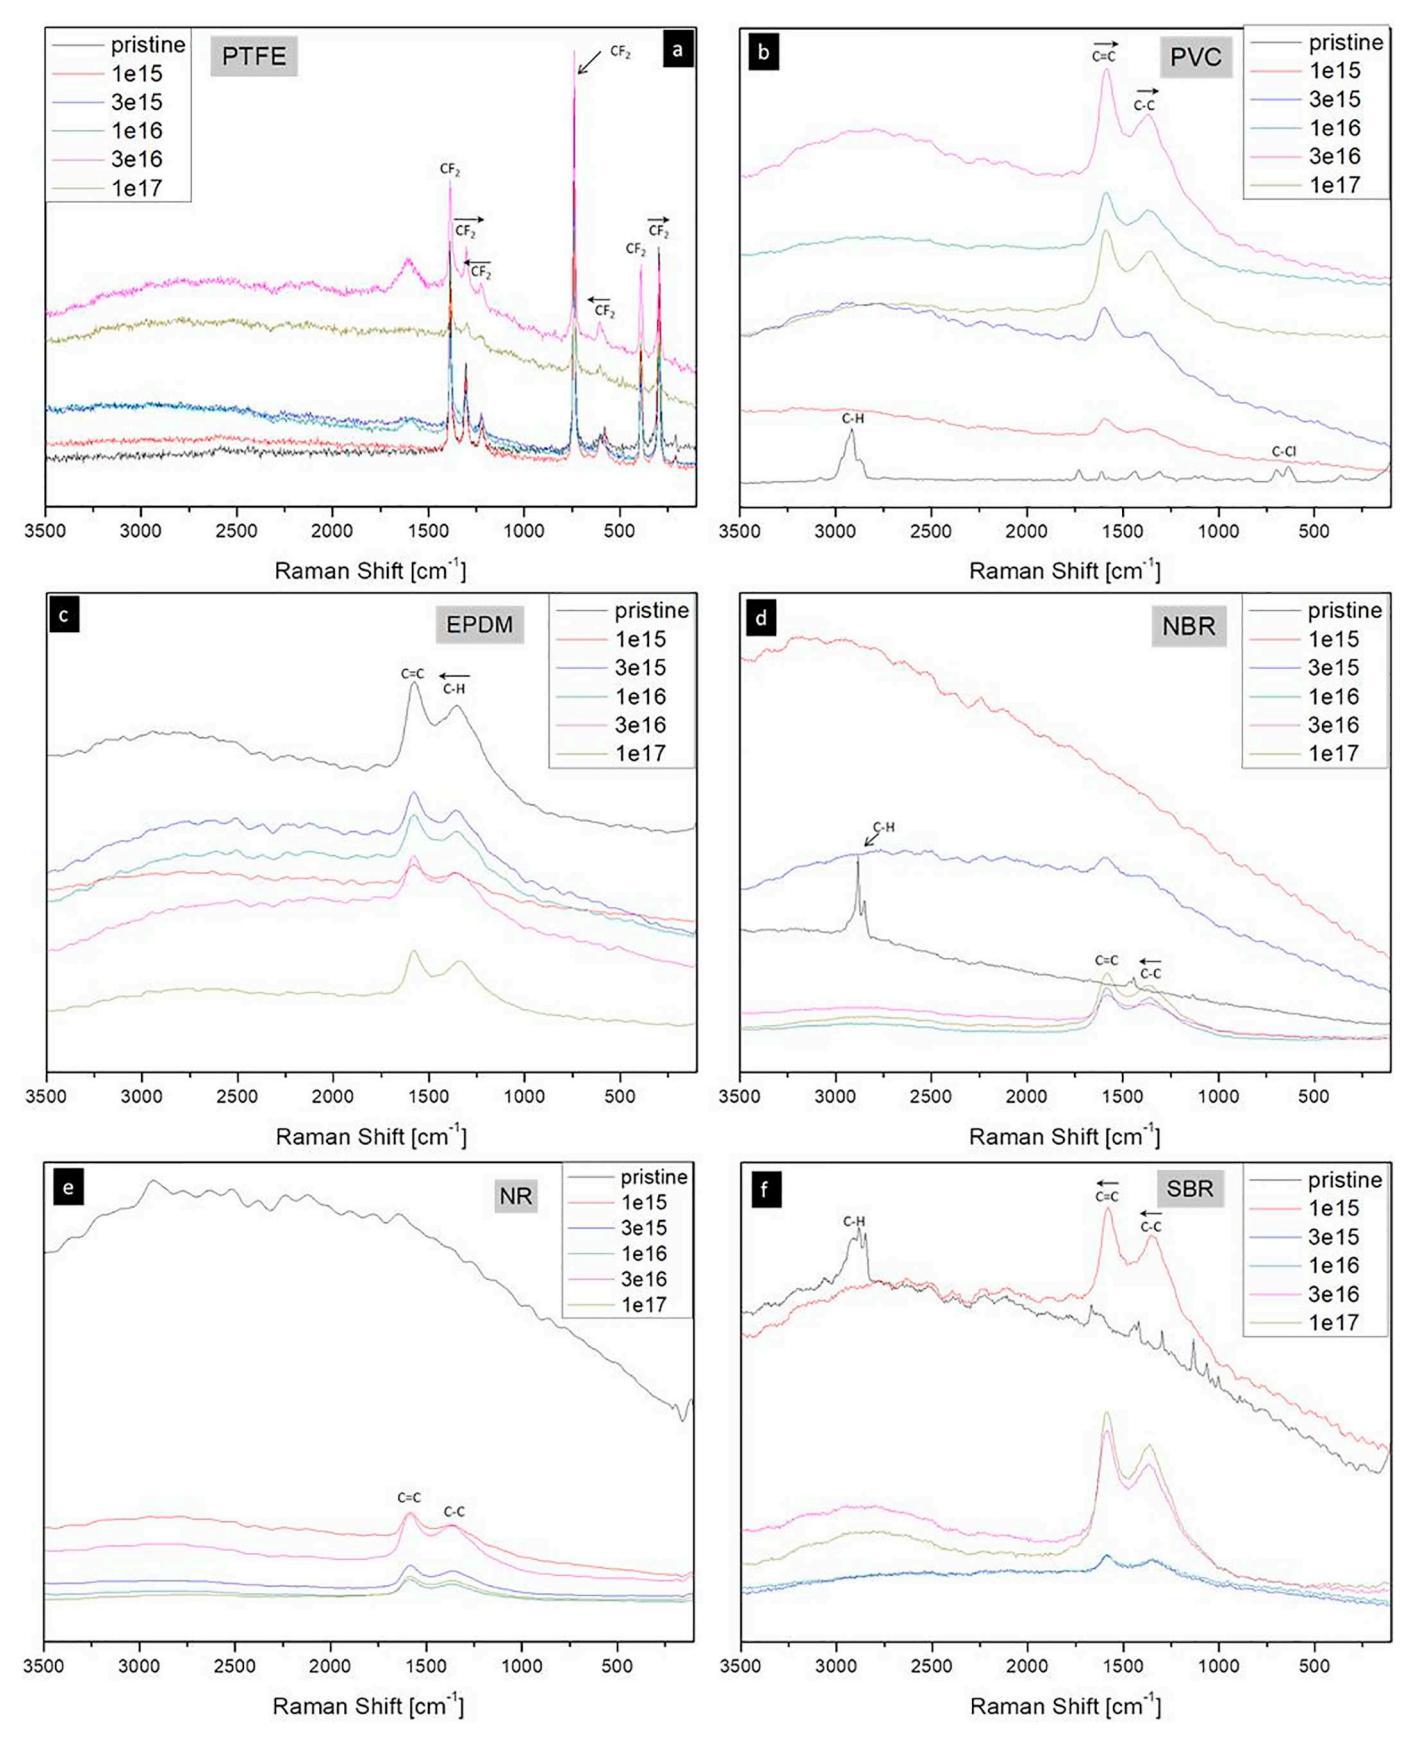
Fig. 1. Raman spectroscopy signal recorded the wavenumber range from 100 to 3500 cm⁻¹ (500–2000 cm⁻¹ for EPDM) for pristine and irradiated polymer samples (Panel a. PTFE; panel b. PVC; panel c. EPDM; panel d. NBR; panel e. NR; panel f. SBR).

Raman spectroscopy was used to determine functional groups of the polymer materials. Fig. 1 presents the most intensive Raman bands - marked with the black arrows. Small band shifts of the certain Raman bands have been denoted in Table 2.

The Raman spectra of commercial PTFE showed (Fig. 1a) evidence of acyl fluoride (COF), CF-CF2 and COO + X end-groups [19]. After irradiation, no changes in the structure of commercial PTFE, except increase in crystallinity (as evidenced by intensity increase of the signal in the region of 700 cm⁻¹) was observed. One can observe signals characteristic for the CF₂ groups in the positions near 298 cm⁻¹ and 390 cm⁻¹, doublet of CF₂ in the positions of 580, 598 cm⁻¹, and finally F₂ symmetry triplet of CF₂ in the positions of 1384, 1307 and 1216 cm⁻¹.

Fig. 1b presents Raman signal recorded in the commercial PVC films. It is known that the PVC material shows a change in the spectrum characteristics which has been observed during irradiation [20]. One can see that all Raman bands present in the pristine sample disappeared after irradiation. At the same time, two bands characteristic for amorphous carbon with sp^2 hybridization appeared. It seems that even the lowest dose of ions effectively degrades the PVC surface. The most

significant changes in the peak intensity were recorded for the region between 1000 cm^{-1} to 1500 cm^{-1} (see, Fig. 1b). The degradation of PVC by the elimination of HCI and the formation of all-tram polyenes is well known and documented [21]. When the first HCI molecule is eliminated, adjacent HCI molecules are quickly split off which leads to a polyene structure. The Raman spectra of commercial PVC show C-CI stretching vibrations at 634 cm⁻¹ and C-H bending vibration at 1438 cm⁻¹. An intense Raman band located at 2916 cm⁻¹ can also be observed. This signal corresponds to stretching vibrations of C–H bonds in the CH₂ structural fragment [22]. Raman spectra of irradiated PVC show two intense Raman bands located at 1377 and 1597 cm^{-1} . These bands appear due to the C-C and C=C stretching vibrations of polyenes and are typical for carbon materials. Raman band located at 1597 cm⁻¹ position is characteristic to stretching vibrations of C=C bonds in conjugated aromatic compounds, while the band located at 1377 cm⁻¹ is attributed to the defect structure of carbon material [23]. When PVC degrades, hydrochloric acid (HCl) is produced, resulting in the formation of C=C bonds which produce absorption peaks in the Raman spectrum. Even if the concentration of these bonds are very low, they are detectable by Raman spectroscopy, even when the amount of HCl lost is about 0.01% [24,25]. In our case, bands located at 1377 cm⁻¹ and 1597 cm⁻¹ reflect to PVC degradation. One can see that Raman band scattering is almost identical for all peaks irradiated PVC. However, small band shift after ion irradiation was observed, see Table 2.

Another polymer tested by using Raman spectroscopy technique was EPDM (Fig. 1c). The most intense Raman band was recorded at 1576 cm⁻¹, which is related to the in-plane vibrations of the graphitic wall. As shown in Fig. 1c, two scattering peaks can be observed at each EPDM sample, regardless of the irradiation dose. The bond located at 1576 cm^{-1} can be assigned to C=C stretching vibration, while the other one located at 1355 cm^{-1} is assigned to C-H symmetric deformation vibration of methyl group [13]. Recorded Raman bands after ion irradiation appear to be less intense.

Fig. 1d shows Raman signal of NBR sample measured in the pristine state and after irradiation. All signals from C–H bonds located at 2883 cm⁻¹ recorded in the pristine NBR disappeared after ion irradiation. Lines obtained from fluence of 1×10^{15} ions/cm² are characteristic for fluorescence effect, which is the reason why no band has been recorded. Sample irradiated with a fluence of 3×10^{15} ions/cm² shows fluorescence as well. However, Raman bands located at 1350 cm⁻¹ and 1583 cm⁻¹ positions can be seen. Fluorescence may be related to the color of the sample. As it is well known black color leads to the appearance of this adverse phenomena. The two bands located at 1350 cm⁻¹ and 1583 cm⁻¹ can be assigned to the C– C and C=C stretching vibrations.

Fluorescence due to impurities has prevented the acquisition of a useful Raman spectrum of NR, see Fig. 1e. Fluorescence is a particular problem in cross-linked materials. This is the main reason why we cannot compare bands from pristine material and material after ion irradiation. The mid-frequency region (1500 to 1000 cm^{-1}) displays the most significant changes [26]. New bands can be seen at 1360 and 1584 cm⁻¹. These positions are characteristic for C–C and C=C bands, respectively.

Most Raman bands of SBR are located in the 1800–900 cm⁻¹ and 3200–2800 cm⁻¹ regions [27]. Stretching vibrations of SBR characteristic for C–C and C=C are observed in the region between 1356 and 1580 cm⁻¹, respectively. Also, the bands located at 1356 and 1580 cm⁻¹ show a relatively large increase in intensity for fluence of 1×10^{15} ions/cm², 3×10^{16} ions/cm², 1×10^{17} ions/cm². Both symmetric and asymmetric –CH2 and –CH3 stretching vibrations typically appear in the 2800–3000 cm⁻¹ region.

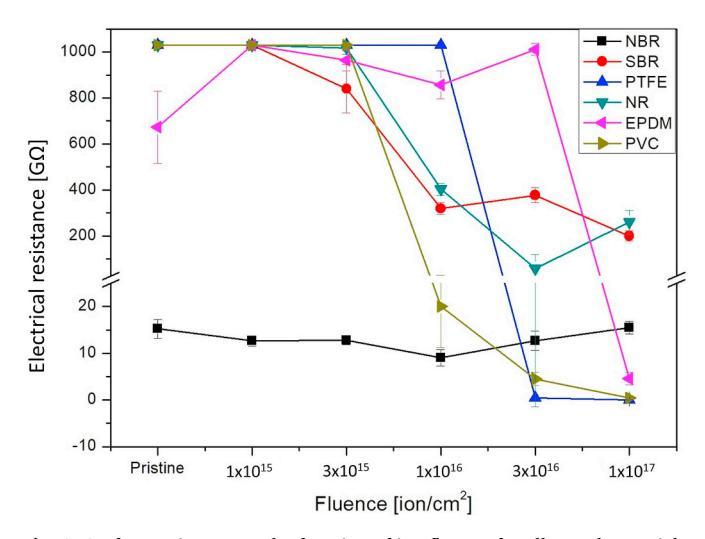
Fig. 2. Surface resistance as the function of ion fluence for all tested materials.

Electrical resistance measurements were performed by using Fluke Insulation tester and show that this value decreases with increasing ion irradiation fluence. One can clearly observe that the smallest impact of radiation damage is recorded for EPDM polymers who shows reduction in electrical resistance at 1×10^{17} ions/cm². Conducted measurements clearly show that significant descent of electrical resistance commence at 1×10^{16} ions/cm² for the rest of the specimens. This effect is most likely related to the changes in material stoichiometry caused by a massive hydrogen release, hence to a progressive transformation of polymer into a graphitic structure (Fig. 2).

Presented results confirm the assumption, that EPDM is the most promising polymer material to be used in radiative environment [28]. At the same time, PVC polymer which is known as the most widely used in radiative environment shows the most surprising behavior. According to our measurements, significant reduction in electrical resistance has been observed already at 1×10^{16} ions/cm². On the other hand, NBR elastomer insulation shows the lowest values of electrical resistance.

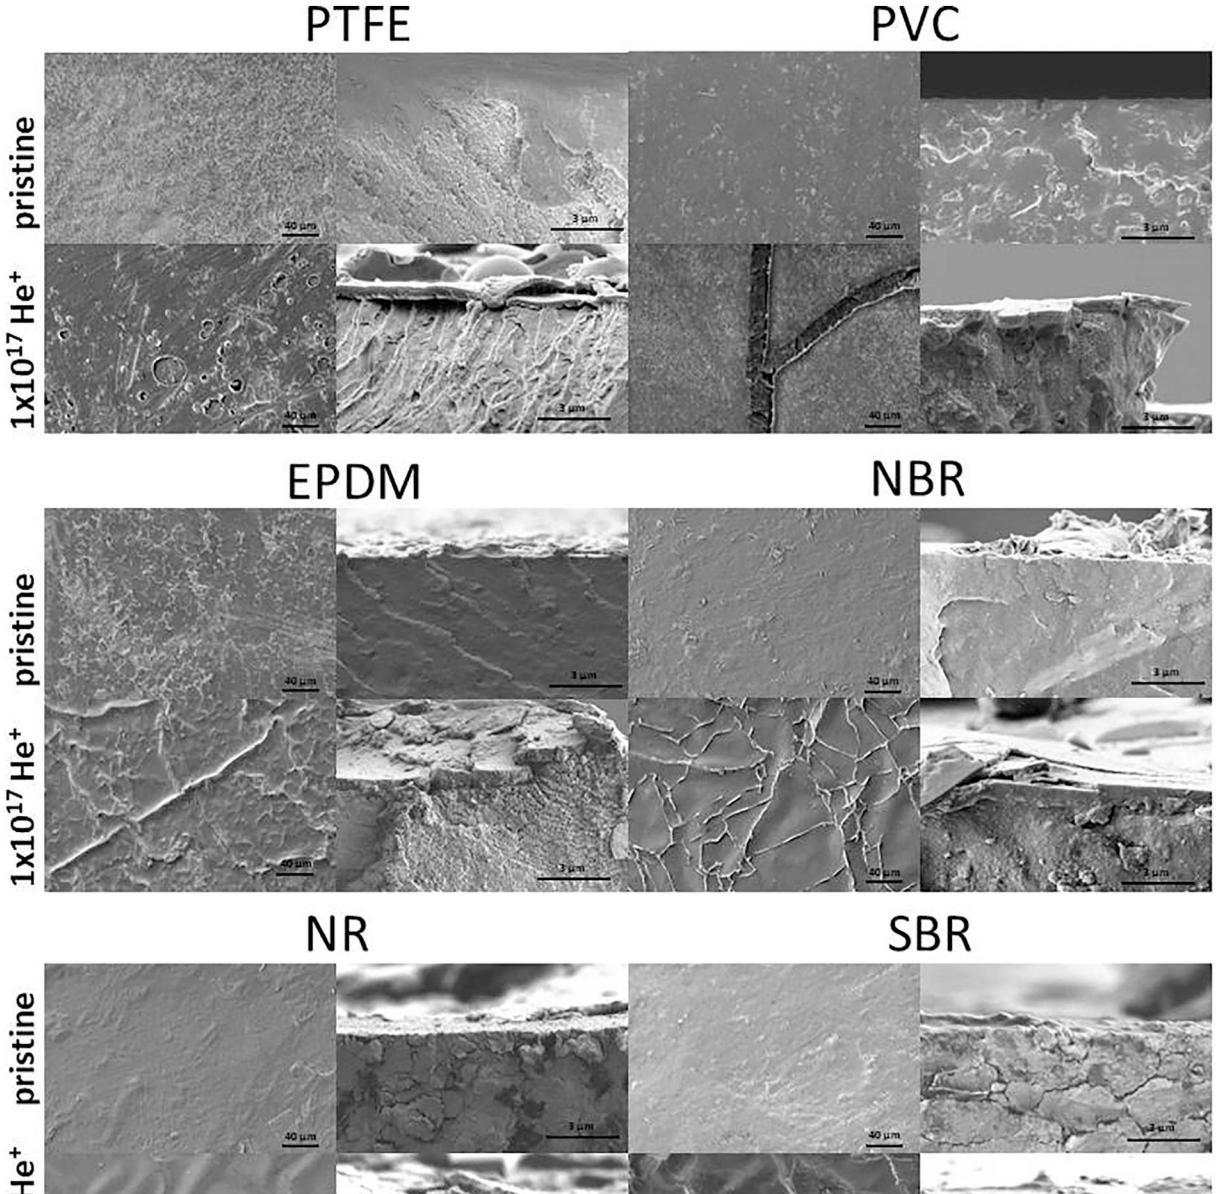
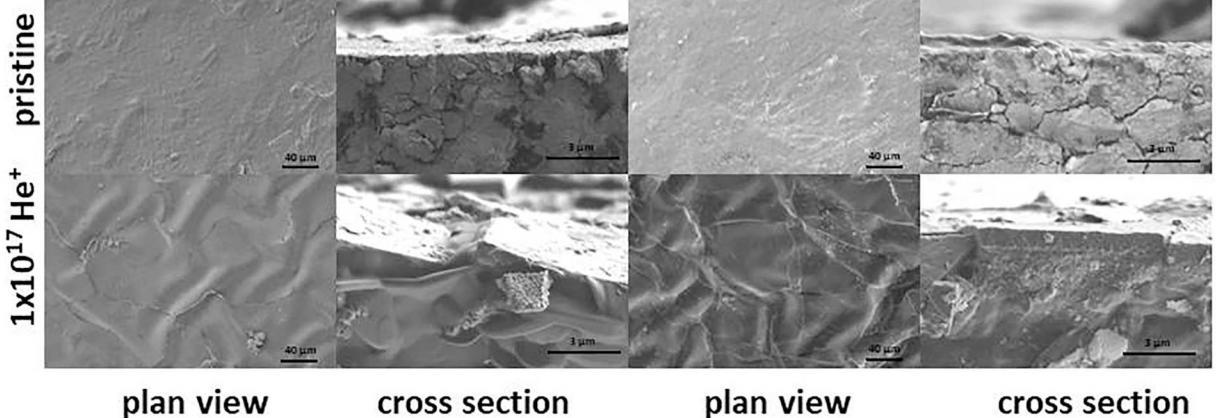
Fig. 3. SEM micrographs showing plan-views and cross-sections of all types of studied polymers before and after irradiation with He⁺ ions.

Finally, SEM plan-view and cross-section micrographs of all studied materials are presented in Fig. 3. The first stage of experiment consisted of He-ion irradiation with 60 keV energy up to the fluence from $1 \times 10^{15} \text{ ions/cm}^2$ to $1 \times 10^{17} \text{ ions/cm}^2$. Presented images (see Fig. 3) clearly shows that ion irradiation cause surface shrinkage and crack development on the elastomer surface layer. Surface smoothing is the effect of degradation of macromolecules and the appearance of short chain fragments on the surface which perform function of a grease can be seen. The material becomes more packed and its volume decreases (density increases).
